Nuclear Instruments and Methods in Physics Research A 515 (2003) 190–195

Additives that prevent or reverse cathode aging in drift chambers with helium–isobutane gas[☆]

A.M. Boyarski

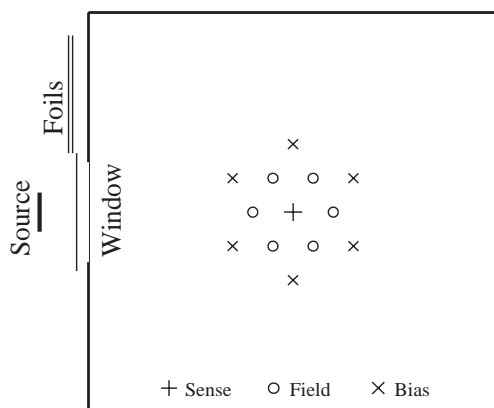
Fig. 1. The test chamber. A single drift cell is enclosed in a square aluminum tube 10.2 cm per side, and 30.5 cm long.

A small test chamber was built having one hexagonal BaBar-like cell as shown in Fig. 1. The sense wire ($20\text{ }\mu\text{m}$ gold-coated tungsten–rhenium) is surrounded by six field wires ($120\text{ }\mu\text{m}$ gold-coated aluminum) at 1 cm wire spacing. The six outer bias wires at 1300 V together with 2050 V on the sense wire provide a 19.2 kV/cm field on the field (cathode) wires and 239 kV/cm on the sense (anode) wire, giving a gas gain of approximately 1×10^5 .

Gamma rays from a $100\text{ mCi } ^{55}\text{Fe}$ source entered the chamber through a thin Mylar window. Attenuation foils were inserted in front of the window to reduce the current to any desired

level. A shutter made of 6 mm thick aluminum could completely attenuate the gamma rays. With the shutter open, the gammas passed through a hole that restricted the ionization to the middle 22 cm of the wires. With the attenuation foils removed, the anode current was 400 nA, and the maximum anode current density was calculated to be approximately 30 nA/cm at the mid-length of the wire.

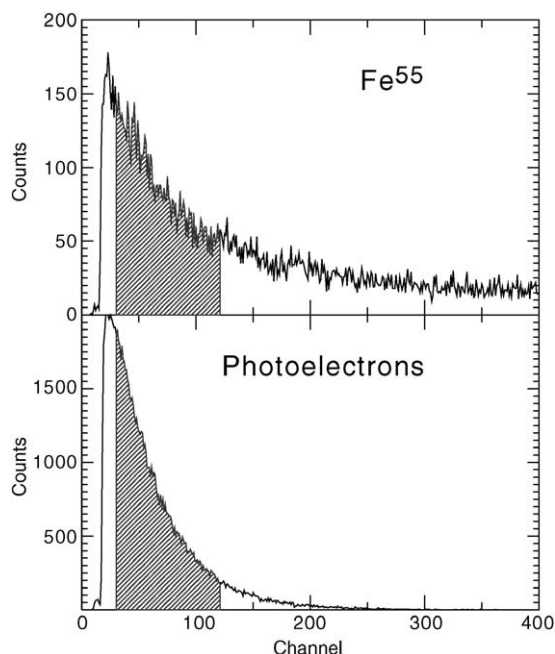
Fig. 2. Pulse height spectrum for small pulses from ^{55}Fe and from single photoelectrons. The shaded channels are used to count single electron avalanches. The ^{55}Fe peak is off scale at channel 5500.

A Pico ammeter (Keithly 487) and a multi-channel analyzer (Perkin Elmer/Ortec 142PC, 570, and TRUMP PCI-8K) measured the cathode current and anode pulse spectrum, respectively. The 8K-channel range in the analyzer could accommodate both the ^{55}Fe peak at channel 5500 and the signal from one-electron avalanches at channel ~ 32 . The analyzer did not record pulse heights below channel 20. The top plot in Fig. 2 shows the small pulse spectrum from ^{55}Fe at a low source level, while the bottom plot shows the spectrum when incandescent light is allowed into the chamber. The latter spectrum is from photoelectrons off the cathode wires, and establishes the shaded channels (30–120) to be used for counting single electron avalanches. The small pulses from ^{55}Fe are due to conversion locations grazing the boundary of the cell with only a single (few) electron(s) reaching the anode.

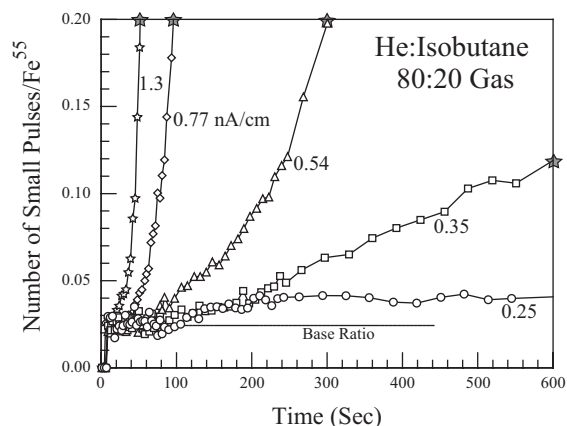
Fig. 3. Transient behavior of small pulses in the helium–isobutane (80:20) gas after opening the source shutter, for various levels of wire current. A star at a boundary indicates that breakdown occurred outside of the plot area.

In order to better understand the onset of the Malter currents, we measured the transient behavior of small pulses in response to a step in chamber ionization. This was done by closing the source shutter for at least 5 min and then by opening the shutter while recording pulse spectra every few seconds. The ratio of small pulse counts to peak counts was then plotted versus time. Such plots were recorded for various chamber currents. Fig. 3 shows the transient behavior of small pulses for wire currents from 0.25 to 1.3 nA/cm in the helium–isobutane (80:20) gas with no additives.

When the source is first opened, the small pulse ratio starts at the same 0.025 base value for all current levels. At the highest current (1.3 nA/cm) the ratio grows rapidly until the chamber breaks down after 60 s. At lower currents, the break down takes longer to develop. At 0.25 nA/cm, the chamber does not break down although there is an increase in the number of small pulses.

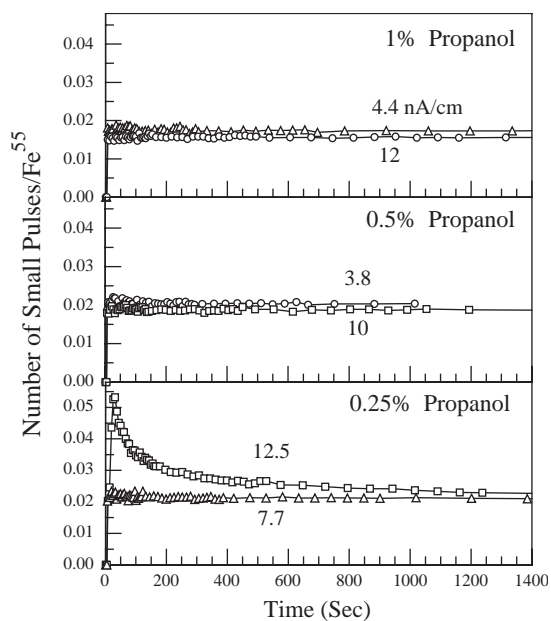
Fig. 4. Transient behavior of small pulses with an alcohol additive 2-propanol. Concentrations above 0.5% show no small pulse activity.

Some additives allowed chamber operation beyond wire currents of 10 nA/cm. The transient behavior with 2-propanol, $\text{CH}_3\text{CHOHCH}_3$, is shown in Fig. 4. At concentrations of 1% and 0.5% there is no small pulse activity for wire

currents of 10 nA/cm or more, while at 0.25% there is an initial increase at 12.5 nA/cm and then a gradual decline. The declining feature is discussed later.

A strange behavior already seen in Fig. 4 (bottom) is the rise and fall of the small pulse activity after the shutter is opened. This was seen for helium–isobutane gas alone, as well as for this gas with each additive studied, for currents slightly below the breakdown threshold. Fig. 7 shows this effect for the helium–isobutane (80:20) gas.

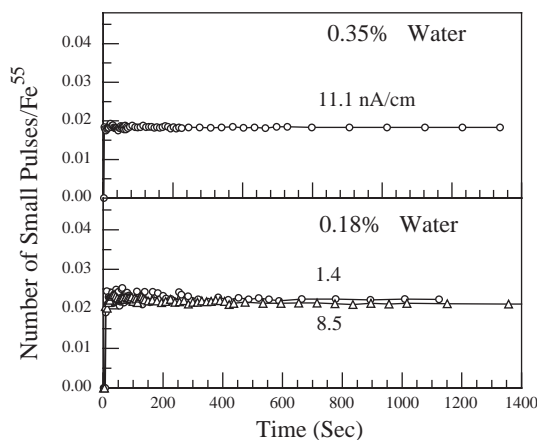
Fig. 5. The small pulse transient behavior with a 0.35% or 0.18% water additive shows no increase in small pulses.

The transient behavior for a water additive is shown in Fig. 5. There is no visible small pulse activity with 0.35% or 0.18% water.

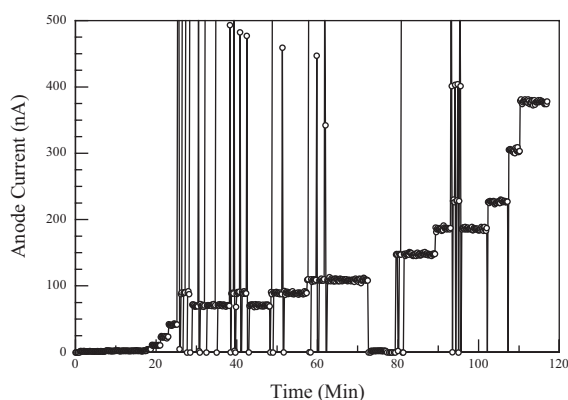
Fig. 6. The anode current during a curing cycle with 0.05% O_2 is shown. The spikes are chamber trips, but after repeated attempts the chamber reaches a stable state at each current level up to the maximum ^{55}Fe source level.

The final two additives tried in this study, O_2 and CO_2 , behaved differently. Whereas the previous additives allowed immediate operation at higher chamber currents, these did not. With O_2 or CO_2 , it was necessary to increase the ^{55}Fe source intensity slowly while keeping the high voltage fixed at the nominal settings. If brought on too quickly, the chamber would ignite in Malter mode, but after repeated attempts would become stable. Fig. 6 shows the anode current with 0.05% oxygen. After 2 h of training, the maximum ^{55}Fe source intensity was reached at an anode current of 375 nA (29 nA/cm current density).

But more importantly, when the O_2 was removed from the chamber gas, the chamber could still operate at the maximum 29 nA/cm current density. The O_2 additive was able to cure a damaged chamber. This measurement was repeated several times (by damaging the chamber

The fact that the chamber could not operate immediately at high currents with oxygen, but had to be slowly trained, is indicative that the oxygen reacts with and removes ingredients on the wires over a period of time. It requires both oxygen and a high chamber current to cure the chamber. Most likely, the ionic current passing through the high electric field near the wire surface heats up the local gas, which allows reaction of oxygen with the carbon-based deposits (polymers) on the wire surface. The CO , CO_2 , etc. combustion products are removed from the chamber by the flowing gas.

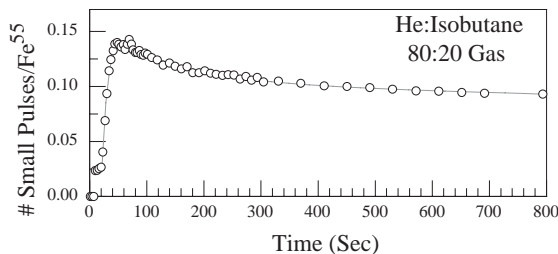
Fig. 7. Small pulse activity at ionization levels just below the breakdown threshold shows a rise and then a fall from a step increase in ^{55}Fe ionization.

The increase in small pulses is readily explained by the Malter theory, in which an insulating deposit on the cathode collects the incoming positive ions and charges up to a point where the resulting high electric field draws off electrons from the cathode through the insulator. As the charge and the electric field build up with time, the rate of emission of electrons also increases as observed, until either Malter breakdown occurs or the charge build-up is balanced by ohmic current flow through the insulator.

But the sudden reduction in small pulses after a build-up period means that some other mechanism turns on which suppresses emission of electrons

from the insulator. A likely candidate is heat. The positive ions gain energy when traversing the 19 kV/cm electric field at the cathode, and this energy is dissipated as heat in the collisions with the gas near the insulator or the insulating surface itself. As the insulator heats up, its effective resistance may fall. The charge build-up would then discharge more rapidly and the emission of electrons would decrease as observed.

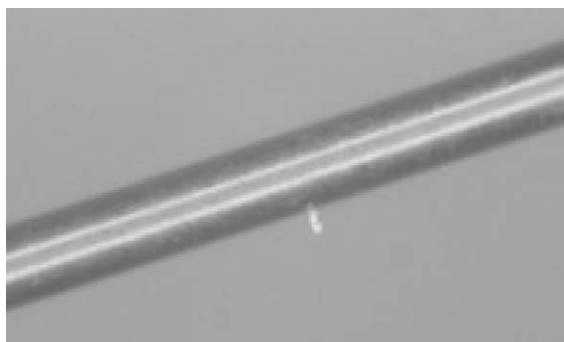
Fig. 8. Picture of a whisker on a 120 μm cathode wire in a damaged chamber.

After the test chamber was maximally damaged, it was opened and the wires were viewed with a microscope. No continuous deposits could be seen on the wires, but many white localized structures or whiskers were found on both the anode and cathode wires. An example of a long whisker on a cathode wire is shown in Fig. 8.

The chamber was then operated with 0.05% oxygen and run until cured to the maximum source strength. The chamber was again opened and pictures were taken of the same regions on the cathode wires. One whisker was gone but others remained as before. The one whisker could have fallen off the wire while transporting the chamber
